**WEST DIKE  
ARLINGTON MILL RESERVOIR  
NH 00029**

**PHASE I INSPECTION REPORT  
NATIONAL DAM INSPECTION PROGRAM**

**AUGUST 1978**

Name of Dam West Dike, Arlington Mill Reservoir  
State Located New Hampshire  
County Located Rockingham  
City or Town Salem  
Stream Spicket River  
Date of Inspection 6/7/78 and 6/28/78

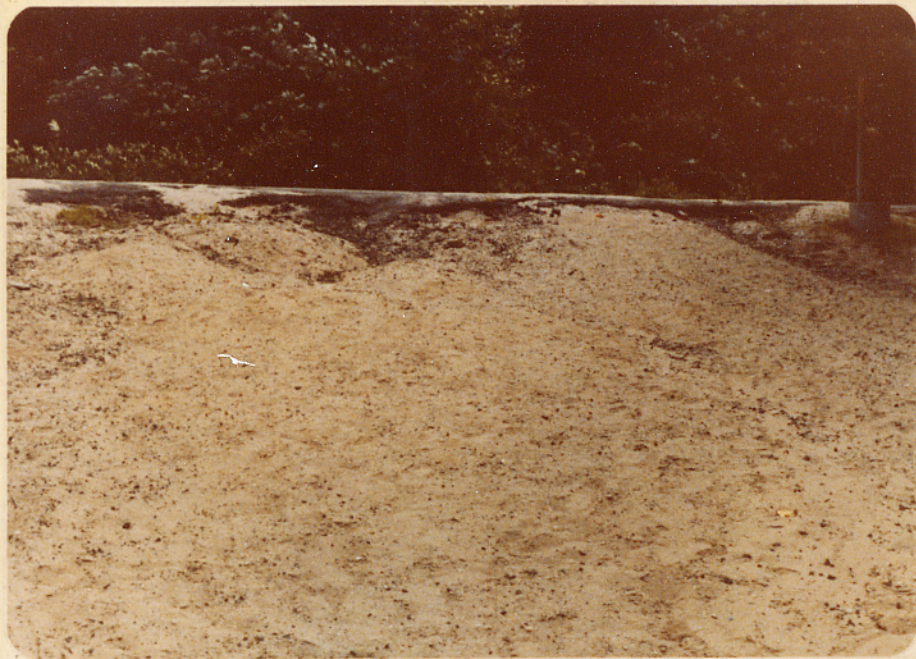
<u>Photo No.</u>	<u>Description</u>
1	Upstream slope of dike looking south from water's edge to crest of dike. Edge of paved road on crest of dike at top of photo. Some erosion of sand immediately below pavement edge.
2	Paved roadway on crest of dike looking from east abutment to west abutment (approximately at location of parked car). Pavement in generally good condition. Trees and brush on downstream (left in photo) side of dike. Unvegetated upstream slope of dike at center of dike (to right of portion of paved roadway which is sunlit across the entire roadway width). Some brush and trees on upstream slope near both east and west abutments.
3-5	<p>Sequence of 3 photos taken clockwise from west abutment, showing: central section of upstream slope which is unvegetated sand, brush on upstream slope near both east and west abutments, utility pipe projecting above ground near upstream edge of paved roadway, and reservoir (visible between clumps of brush at left-center of photo) (3); paved roadway on crest of dike, with east abutment at location where road rises significantly in the background (4); and downstream slope of dike (in right of photo) which is covered with brush (5).</p> <p>Trees and brush cover the ground downstream of the dike. About 20 ft downstream of dike, but not visible in photo there is a wet spot and some standing water. This spot appears to reflect a high water table in the generally low, flat area downstream of the dike and does not appear to be due to seepage through the dike.</p>
